Silica Exposure in Artificial Nail Application Salons

A Publication of the
Illinois Department of Public Health
Division of Epidemiologic Studies
Springfield, Illinois 62761

November 1997

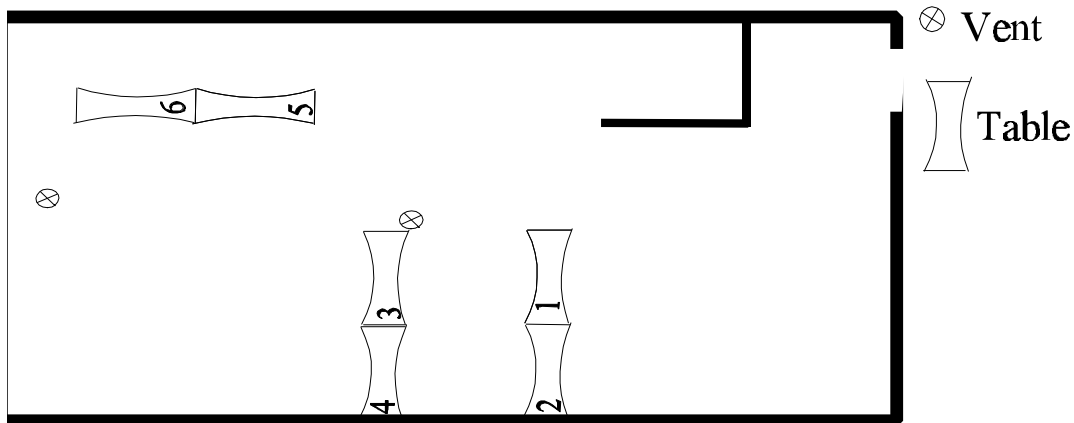
Diagram 1. SALON THREE TABLE ARRANGEMENT

Silica exposure depended on the number of nail technicians, the arrangement of work tables, and the time spent at the work station. Diagrams 1 and 2 show the table layout in the two salons that had multiple technicians. Side by side table arrangements could result in dust exposures to a technician who sits at the work station during breaks, while the adjacent technician is filing nails and generating dust. Air movement and its subsequent dust may cause the technician on break to breathe dust contaminated air.

Ceiling mounted exhaust fans in each of the salons were not adequate to remove the ethyl methacrylate vapors that were evident during the observation. If the exhaust vents could not remove the vapors, it is very possible that the dust, which is heavier, was not removed. The exhaust vents were not positioned properly to allow air movement in a vertical column. The ceiling height was too high to allow laminar air flow from floor to ceiling; therefore, turbulent air flow caused the airborne vapors and silica dust to mix throughout the room.

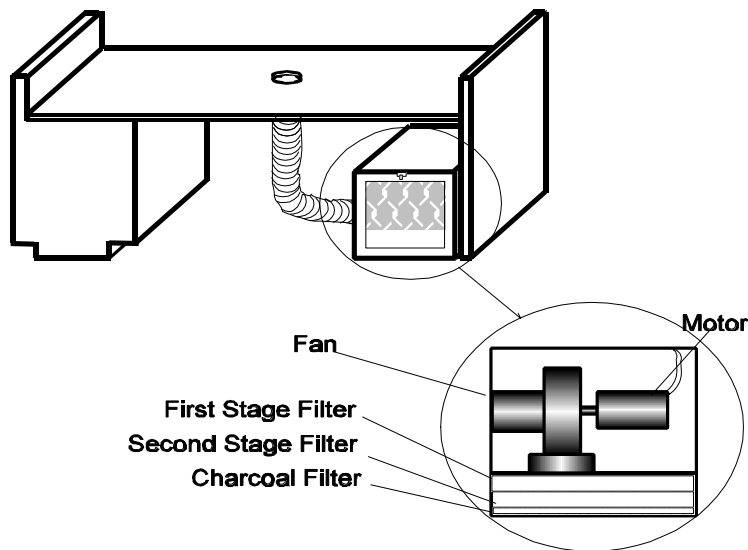
Diagram 3. DOWN-DRAFT SALON TABLE WITH FILTER BOX

Salons Four and Five used down-draft work tables as illustrated below (Diagram 3). The exhaust fan is rated at moving 144 cubic feet of air per minute. The manufacturer states that the fan's exhaust blows through a three-stage filter. One stage removes dusts, the second stage removes fine dusts that passed through the first stage, and the third stage is an activated charcoal filter to remove organic vapors. Exhaust air flows into the salon. After receiving permission to open the boxes to read

the fans' flow rates, staff found that the charcoal filters were missing. Without this charcoal filter, organic vapors from the acrylic application are not entrapped and thus enter the room's air system. In addition, most nail technicians cover the table's hole with a terry cloth towel. The purpose of this towel is unclear. Possible purposes for the towel are to keep the table top clear of acrylic build up, to reduce the fan's flow rate and prevent the acrylic from drying too fast, or to provide comfort for the client's hands.

The down-draft table's manufacturer states that the table's fan is designed to run continuously without affecting the warranty. Nail technicians were observed using the fans intermittently during the day. Three used the fan continuously while one did not turn the fan on at all. Two technicians turned the fan on during filing and turned it off after the filing was completed. If the down-draft fans were used continuously, it would be expected that average respirable dust exposure would go down. For this type of down-draft table to be effective, however, the filters must be maintained and the fan must be running. Filters should be the type made specifically for the fan box and replaced when stated by the manufacturer. Elimination of even one filter element circumvents the air purification system.

Personal breathing zone silica exposure was not above the NIOSH REL. Ventilation systems to limit dust exposure and organic vapors emitted during nail application, however, are important for nail technicians. A good ventilation system should keep vapors and dusts from entering the technician's personal breathing zone and remove the vapors and dusts from the room. Nail salon technicians, though, should not have to remember when to change the filters. Having the air exhausted to the outside of the building is more practical, as the table's down-draft fan would need no filter; thereby requiring no maintenance.
